Laboratory No. M05-1100 Rev. 1.0

Topic: Testing of Post Anchor Assemblies

November 3, 2005

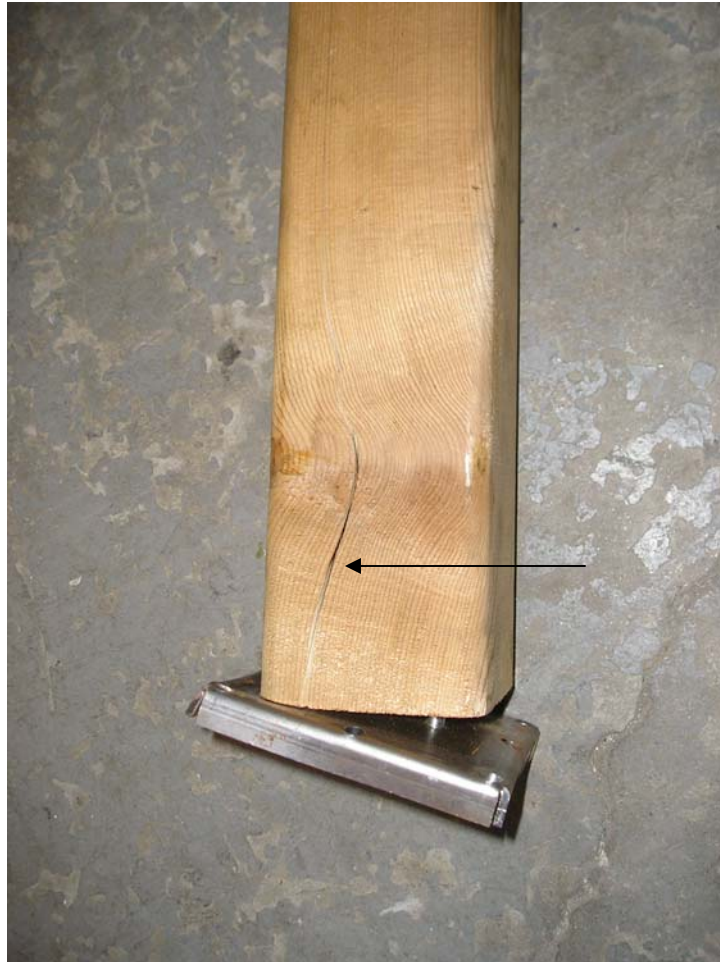
Figure 1

The cedar post was subjected to horizontal static loading at a post height of 1070mm. The maximum recorded strength prior to failure was 0.89 kN/m. Failure occurred when the post split adjacent to the anchor, and the anchor fastening screws stripped from the post. Table 1 contains a comparative summary.

Photograph showing the failure location of the cedar post.

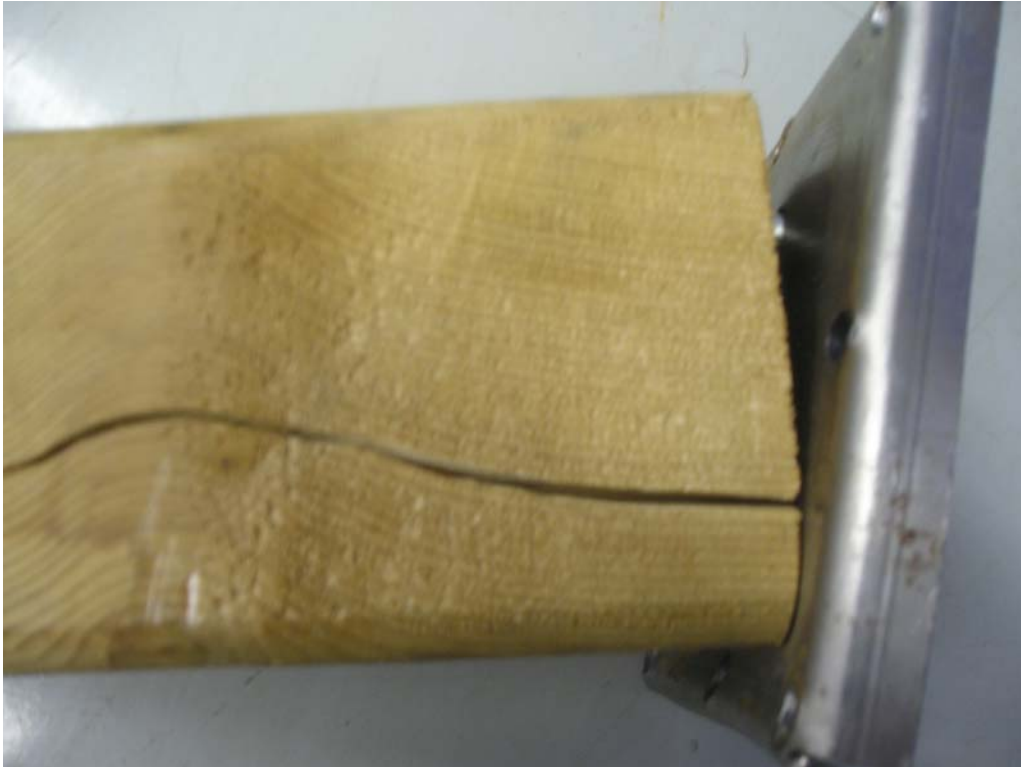
Figure 2

A closer view of the cedar post fracture.

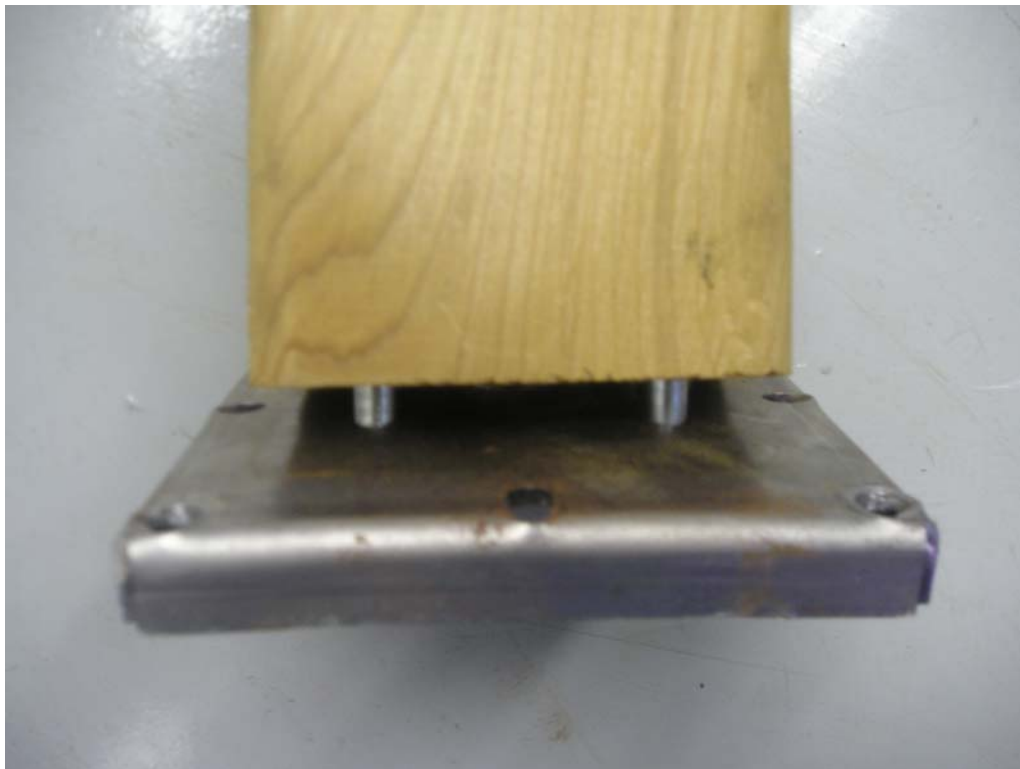
Figure 3

Another view of the failure location on the cedar post

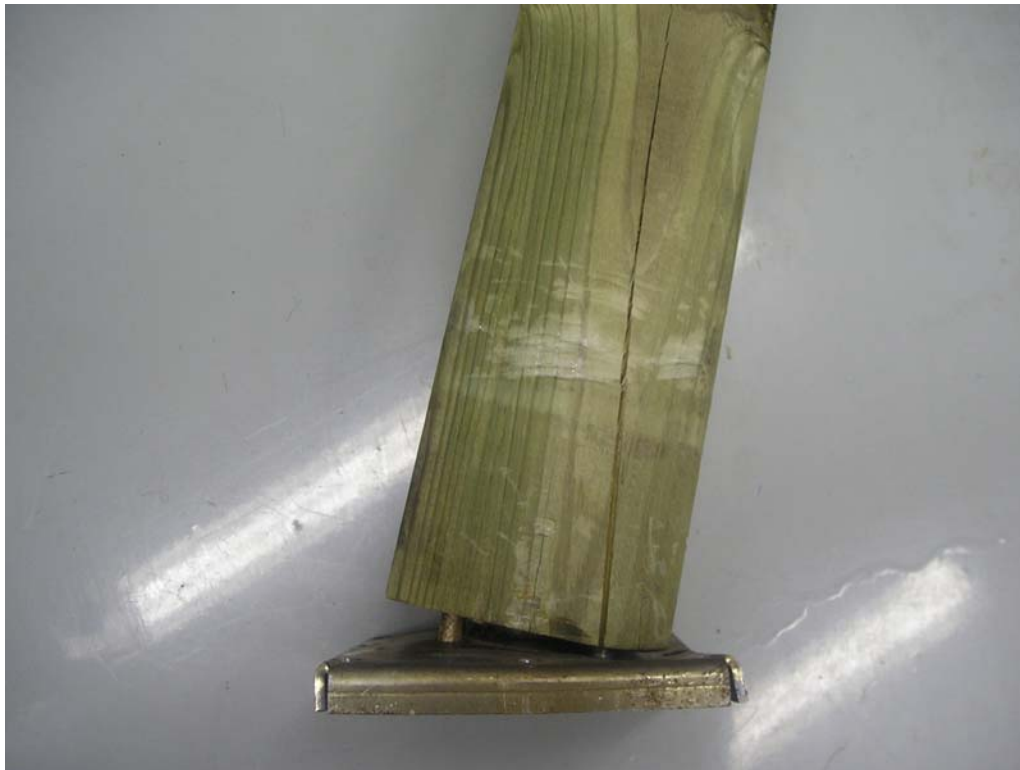
Figure 4

The pressure treated post was subjected to horizontal static loading at a post height of 1070mm. The maximum recorded strength prior to failure was 0.76 kN/m. Failure occurred when the post split adjacent to the anchor, and the anchor fastening screws stripped from the post. Table 1 contains a comparative summary.

Photograph showing the failure location of the pressure treated post.

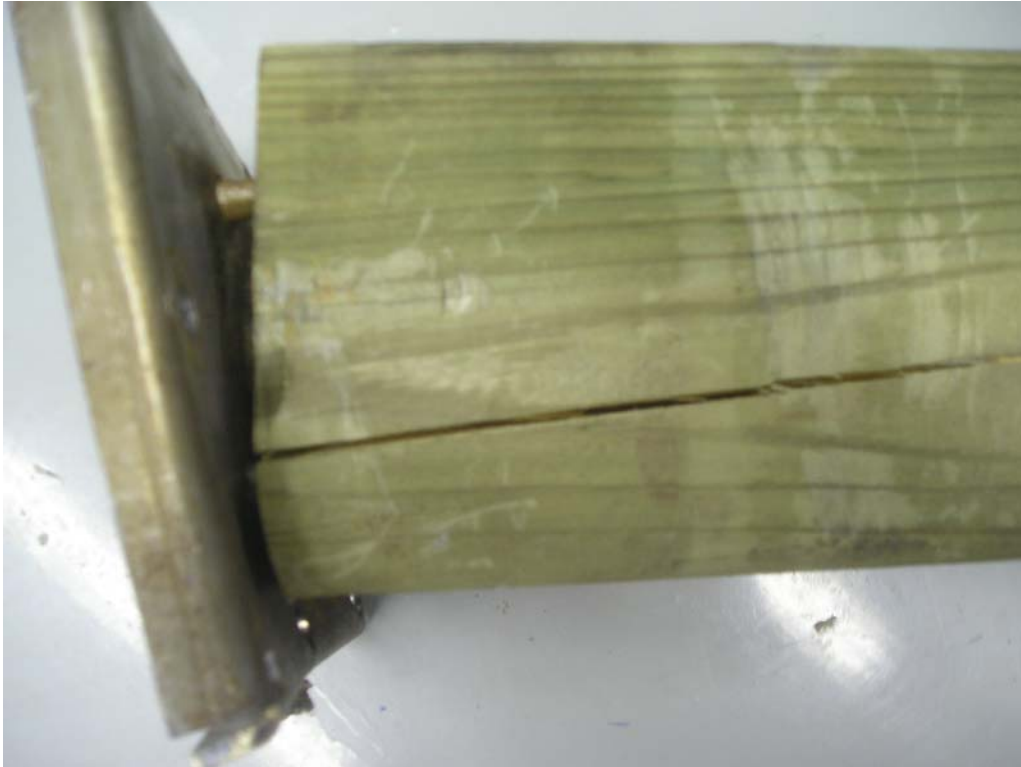
Figure 5

A detailed view of the pressure treated post fracture

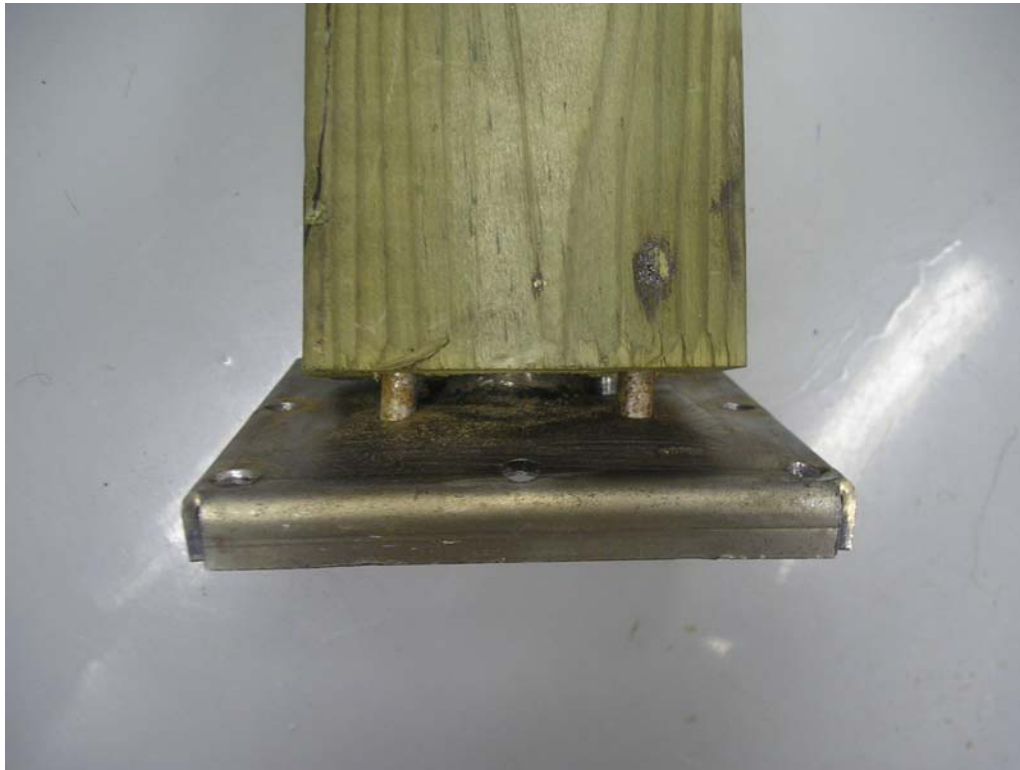
Figure 6

Another view of the failure location on the pressure treated post
